*Monitoring Completed Navigation Projects Program*

## **Periodic Inspection of St. Paul Harbor Breakwater, Alaska**

Robert R. Bottin, Jr., and Alan C. Jeffries

February 2001

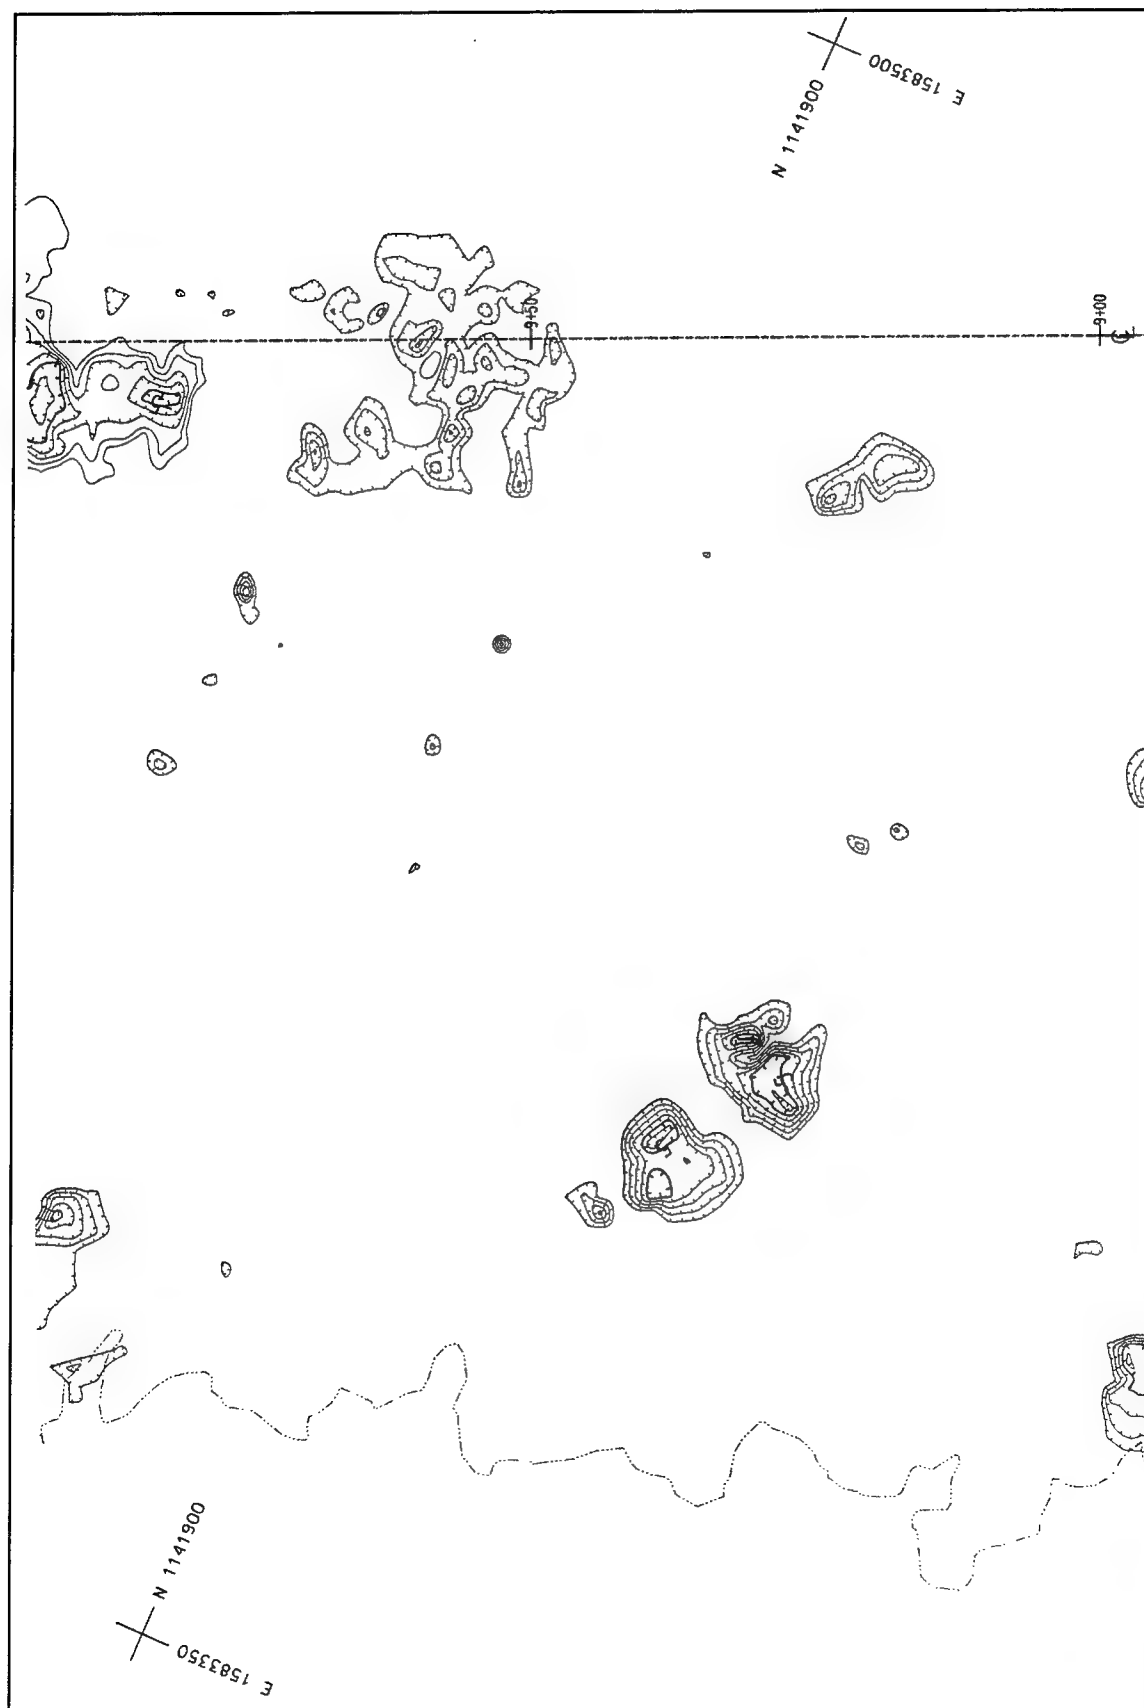
Figure 11. Example of difference contours for breakwater between 1996 and 2000

Maps developed depicting changes in contours between 1996 and 2000 revealed several areas in the breakwater where voids or subsidence (on the order of at least 1.5 m (5 ft)) have occurred. On the seaward slope, decreases in breakwater el were noted between sta 7+70 and 8+45 and sta 8+80 and 9+70; and on the shoreward slope between sta 8+80 and 9+30 and sta 13+90 and 14+15. Difference contour maps also revealed voids in several areas along both slopes of the breakwater as well as the crest where single armor units have been displaced.

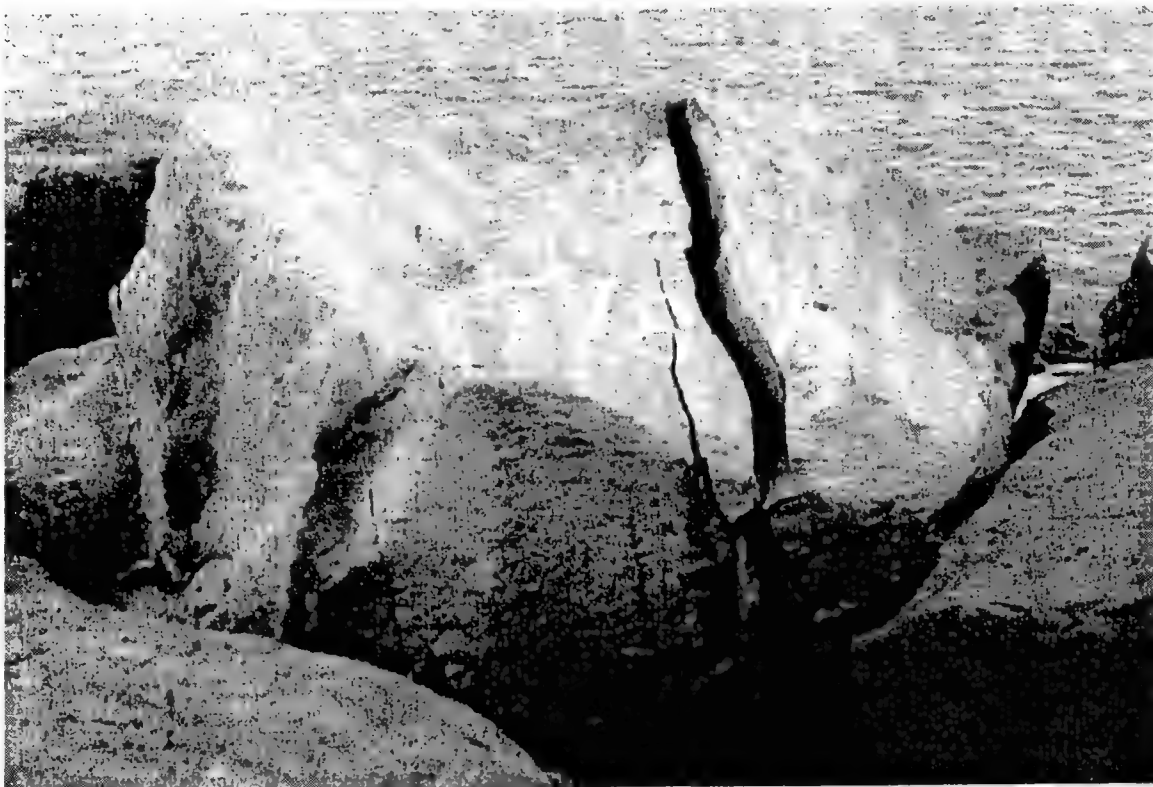
Figure 12. View of broken armor stone on St. Paul Harbor breakwater (sta 9+61)

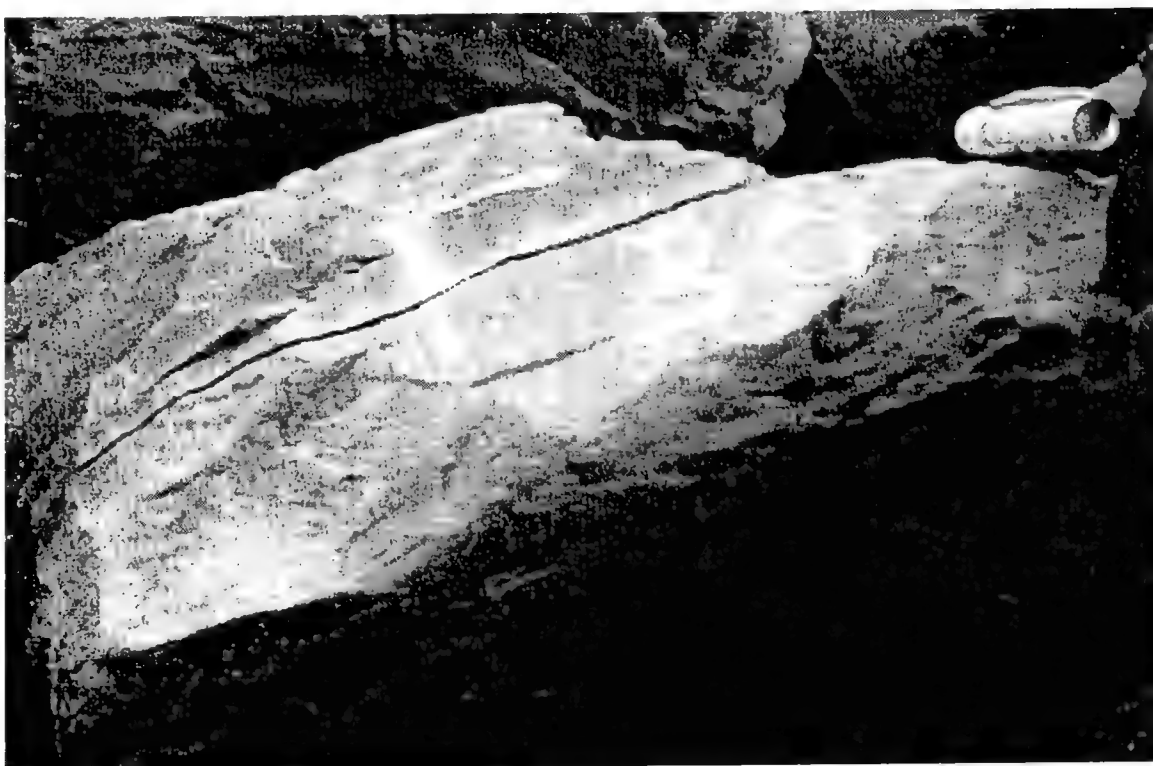
Figure 13. View of broken armor stone on St. Paul Harbor breakwater (sta 11+03)

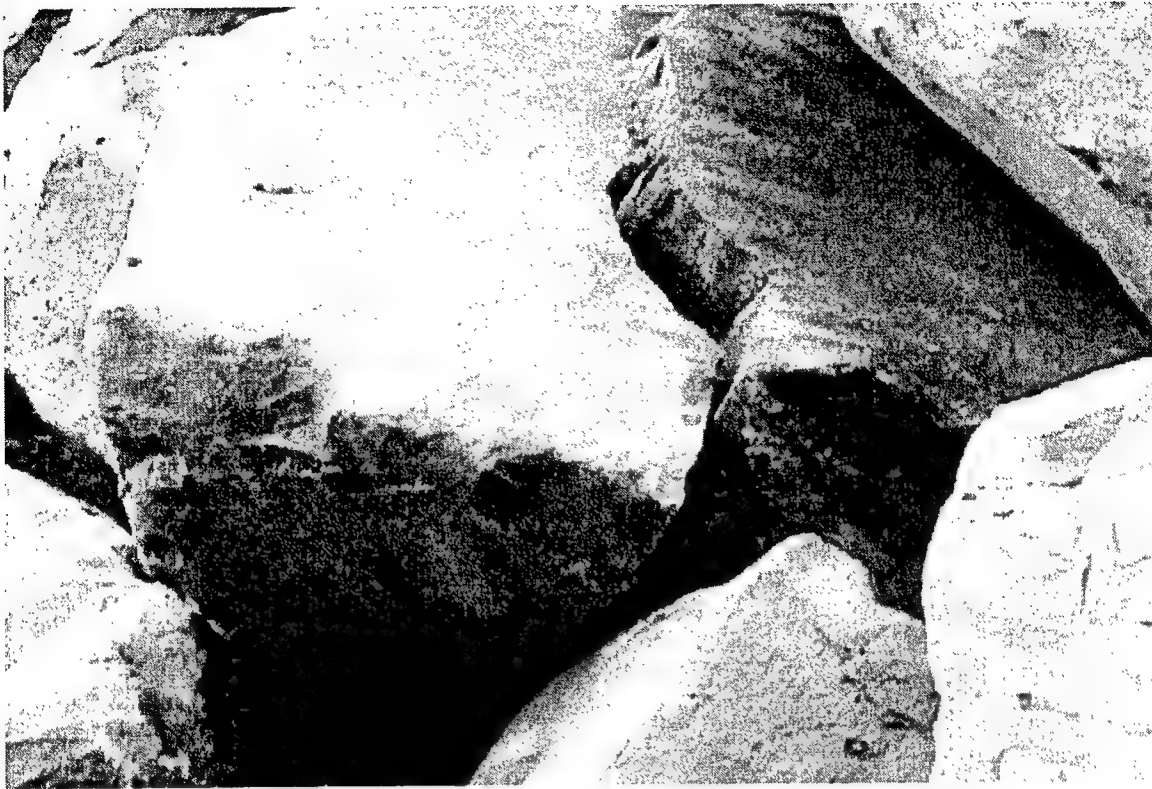
Figure 14. View of broken armor stone on St. Paul Harbor breakwater (sta 16+08)

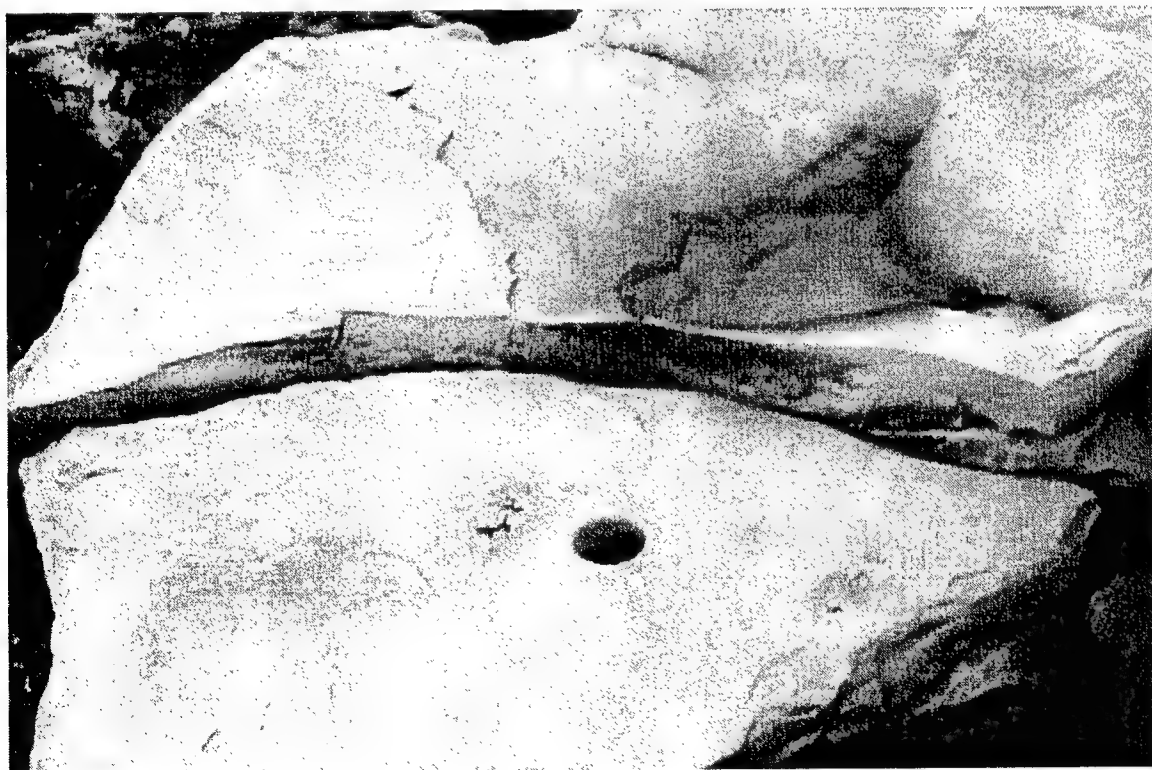
Figure 15. View of broken armor stone on St. Paul Harbor breakwater (sta 17+34)

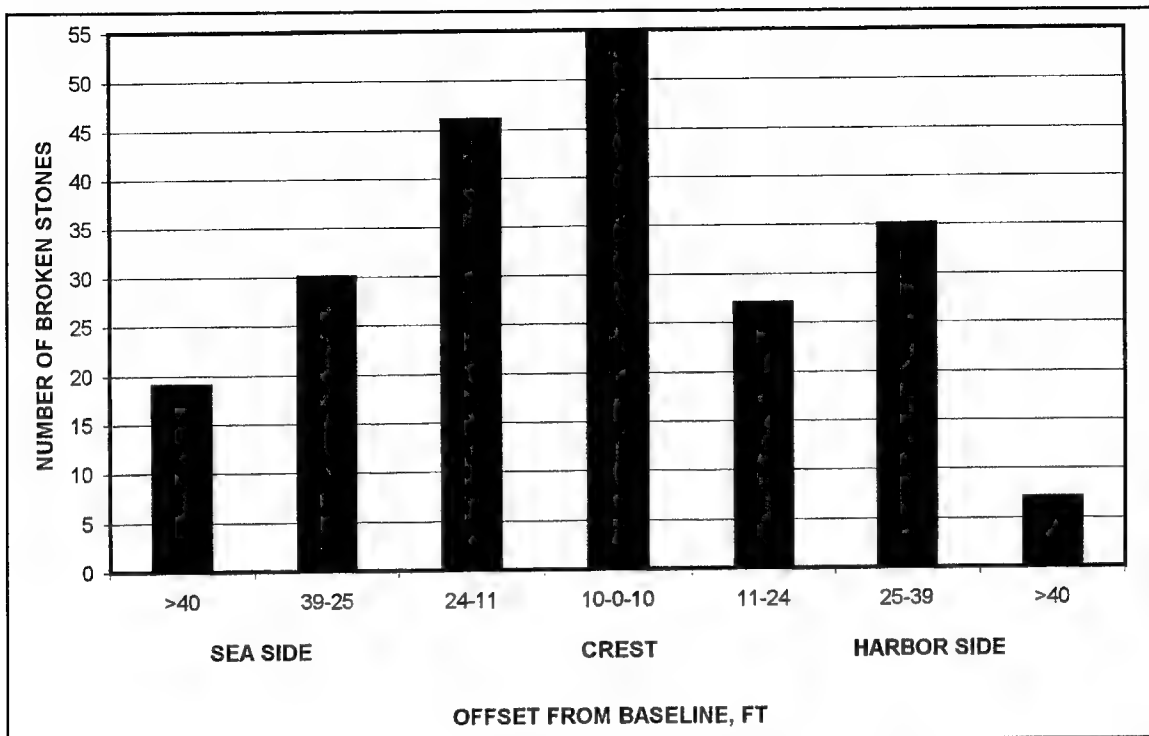
Figure 17. Distribution of broken armor stones relative to distance from baseline (To convert feet to meters, multiply by 0.3048)

The survey revealed a total of 221 broken or cracked armor stones above the waterline. A total of 219 broken stones was noted on the trunk of the breakwater with only two observed around the head of the structure. Of the 219 stones along the trunk, 55 were located along the breakwater crest, 95 on the sea side slope, and 69 on the harbor side slope. The distribution of broken armor stones along the breakwater trunk as a function of station number and offset from the baseline is shown in Figure 16. Broken stones were, in general, relatively evenly distributed along the length of the structure. The survey indicated that 54 percent of the broken stones were located on the shoreward half of the breakwater extension and 46 percent were on the outer half. About 25 percent of the observed stones were along the crest, 43 percent on the seaward slope, and 32 percent on the harbor side slope. Of the broken stones located on the breakwater slopes, the survey revealed that 44 percent of the broken stones were located on the upper half of the slopes (28 percent on the sea side and 16 percent on the harbor side; and 56 percent were on the lower half of the structure slopes (30 percent on the sea side and 26 percent on the harbor side). The distribution of broken/cracked armor units relative to offset from the baseline is shown in Figure 17.
